TECHNICAL BULLETIN

No: LA-204-001
Issue: 1
Date: 02 May 2005

Air Suspension Connector Water Ingress

Land Rover LR3 (LA)

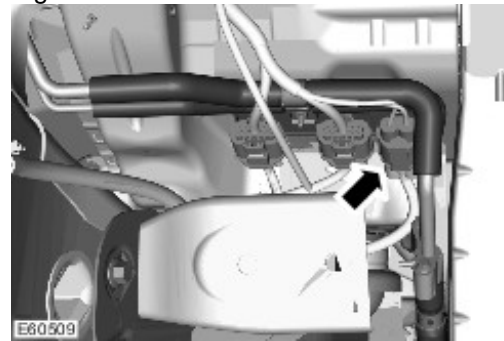
Figure 1

4. Refer to GTR section 76.10.48 and release the rear lower edge of the LH fender splash shield.
5. Position the fender splash shield aside in order to gain access to the electrical connectors.
6. On vehicles fitted with rear air conditioning, release the 'P' clip securing the air conditioning pipe to allow access to the connector. (Figure 1 shows correct routing of the wiring harnesses in front of the air conditioning pipes.)

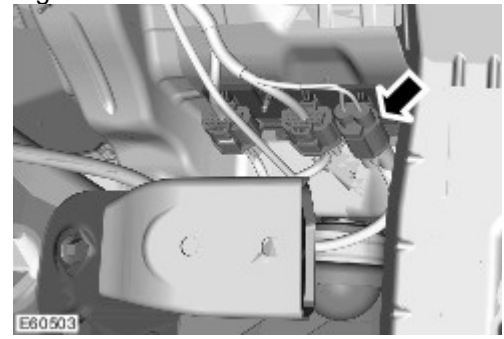
Figure 2

A customer may report incorrect operation of the air suspension or the electronic park brake (EPB) system. Air suspension diagnosis may determine that there is intermittent power supply to the air suspension compressor, or intermittent operation of front RH corner valve. EPB diagnosis may reveal a low voltage fault coded in the EPB module as well as constant or flashing amber EPB warning lamp illumination. Water ingress into the air suspension connector C2528 located at left-hand front wheel arch may be the cause.

7. Locate and remove from its mounting bracket the blue connector C2527/C2528 at the rear of the wheel arch. (Figure 2)
8. Cut the electrical wires as close as possible to the connectors and discard the old connector.
9. Reposition the wire identifiers if installed.
