# TECHNICAL BULLETIN

No: LA-417-001

## Headlamp Condensation

Land Rover LR3 (LA)

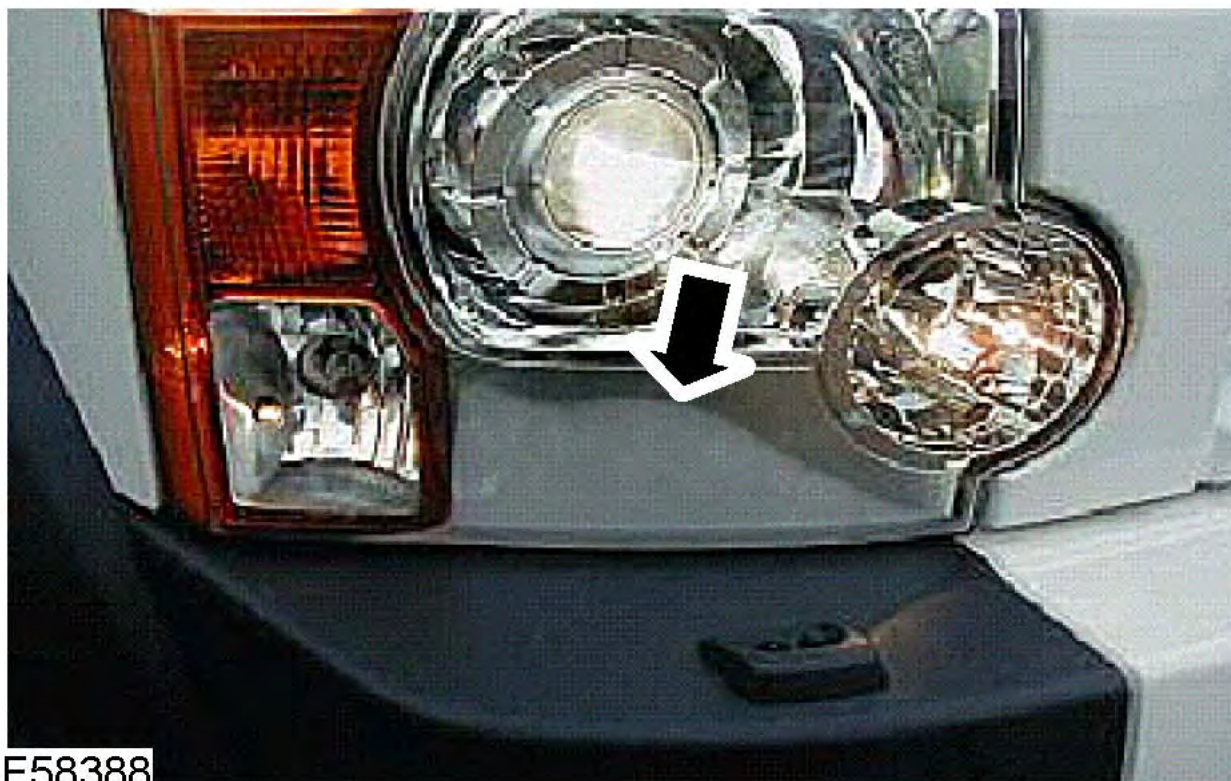
- Headlamps with no visible condensation.
  - No drip marks/streaks in the finely condensed film on the interior side of the clear plastic lens. [Refer to Attachment 4.](#)

Illustration Attachment 4 Headlamp Condensation NOT Covered by Warranty -

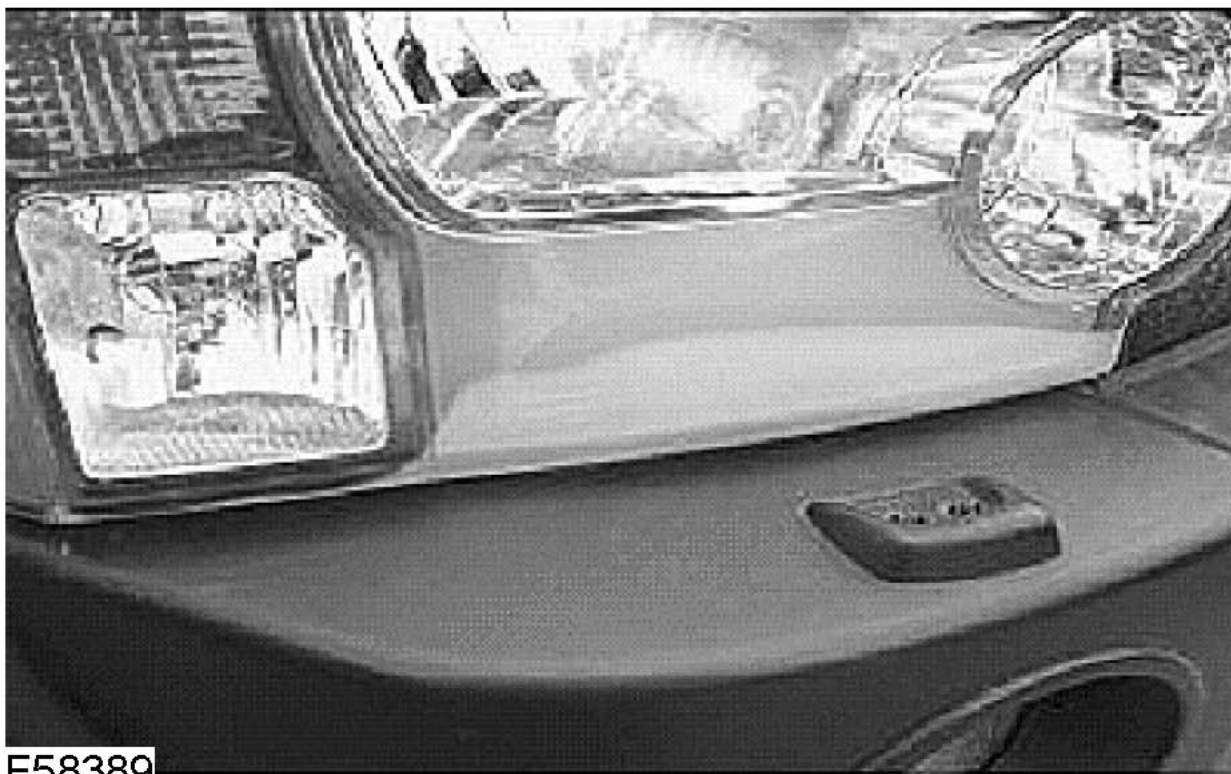
- No visible water droplets in the thin mist. [Refer to Attachment 5.](#)
  - The fine mist does not obstruct the view of the interior of the lamp. [Refer to Attachment 6.](#)

**Illustration Attachment 5 Headlamp Condensation NOT Covered by Warranty**

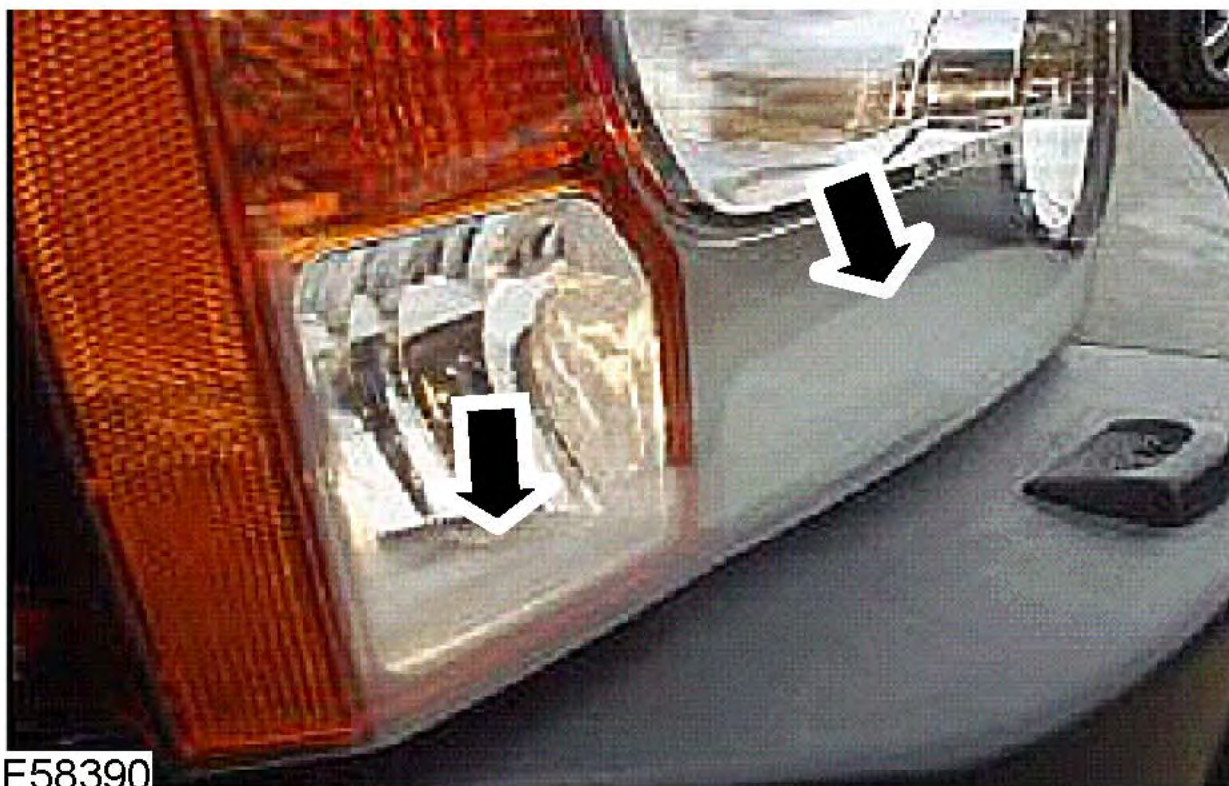
### Illustration Attachment 6

Headlamp Condensation NOT Covered by Warranty (Mist does not obstruct the view of the lamp's interior)

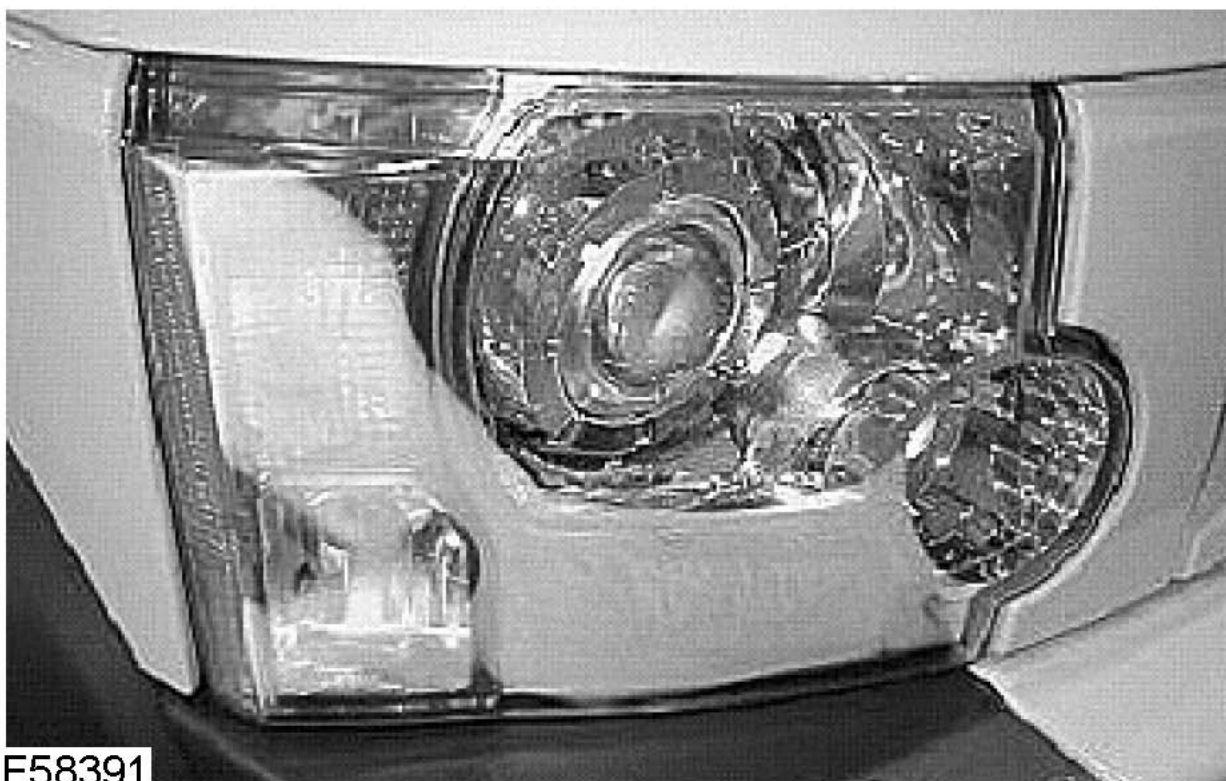
## Illustration Attachment 7

- Condensation covers less than 50% of the interior side of the lens. [Refer to Attachment 7.](#)
1. Verify that the lamp meets the "non-warrantable" conditions in Attachments 4 through 7.

Headlamp Condensation NOT Covered by Warranty - 4 (Fine mist covers less than 50% of the lens)
