TECHNICAL BULLETIN

No: LA-501-001

Door Casing Protective Material Removal

Land Rover LR3 (LA)

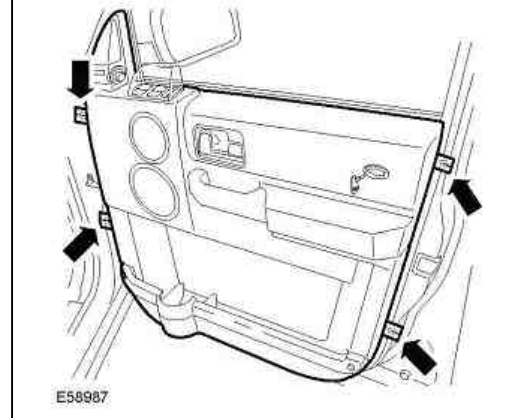
Figure 1

Incorrect removal of door casing protection during Vehicle Preparation (PDI) may lead to customer concerns of a rattle from any of the four side doors door casing or a water leak. The protection can tear if not correctly removed. The material trapped between the door casing clips and the door gasket/seal can flutter to give a rattle and it also can create a water leak-path. Follow the process outlined in the Repair Procedure to ensure correct removal without leaving protective material tab remnants.

1. Remove the front door protective cover as follows:
 - Locate the four taps on the front door protective covers. (Figure 1)
 - Carefully release each door casing cover tab from the tab clips before removing the protective cover. (Figure 3)
 - Remove the protective cover.
2. Remove the rear door protective cover as follows:
 - Locate the four taps on the rear door protective covers. (Figure 2)
 - Carefully release each door casing cover tab from the tab clips before removing the protective cover. (Figure 3)
 - Remove the protective cover.
