TECHNICAL BULLETIN

No: LA-501-003

TAILGATE OPERATION DIFFICULTIES

Land Rover LR3 (LA)

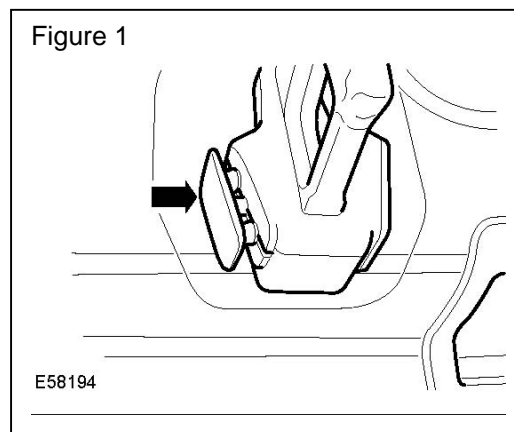
Figure 1

1. Visually inspect the plastic wear-plates on the upper tailgate striker, rubber-buffer. (Figure 1)
2. Verify the wear-plates have a cambered surface (Figure 2) rather than a large flat plain surface.

3. If the surface is flat (early production specification) replace with new part (DIC501360).

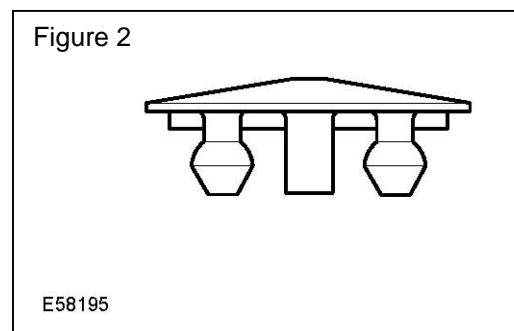
Figure 2

△ **NOTE:** The correct wear plates have been installed on production vehicles from VIN 5A000383.

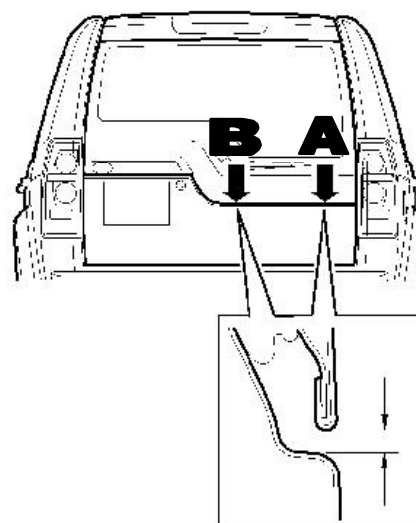
Figure 3

- Gap 'A' is vertically in line with the hinge joint of the upper and lower tailgate. (Figure 3)
- Gap 'B' is in line with the end of the wiper arm. (Figure 3)
- Gap 'C' is the cosmetic gap on the angle of the tailgate below the wiper arm. (Figure 4)

- Insert the jaws of the vernier to the end of the cambered edge of the lower tailgate inner panel.
- Extend the jaws to contact the lower edge of the upper tailgate. (Inset Figure 3)
- Measure gap 'C' with the vernier perpendicular to the angled gap under the rear wiper.

NOTE: Gap 'C' needs to be maintained at or above 6mm (0.236 inch). Gap 'C' maximum design limit is 9mm (0.354 inch). However, The 'C' dimension should be within 1mm plus or minus of the gap at measurement locations 'A' and 'B' to keep the overall gap between the upper and lower tailgate the same.

2. If the gap is less than 6mm at 'C,' increase it to the correct measurement as follows:

- Adjust the lower tailgate to the left in the horizontal plane by 1mm.
- Verify that the gap to the left-hand tail-lamp is greater than 3mm.

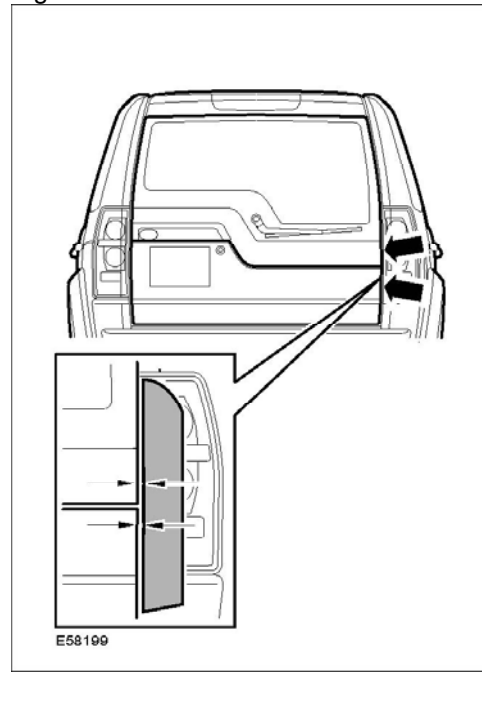
Figure 5

NOTE: A difference in measurements between the gap of the upper tailgate/tail-lamp and the gap of the lower tailgate/tail-lamp, can indicate that the lower tailgate is incorrectly set in the horizontal plane.

3. Adjust the lower tailgate to re-align. (Figure 5)

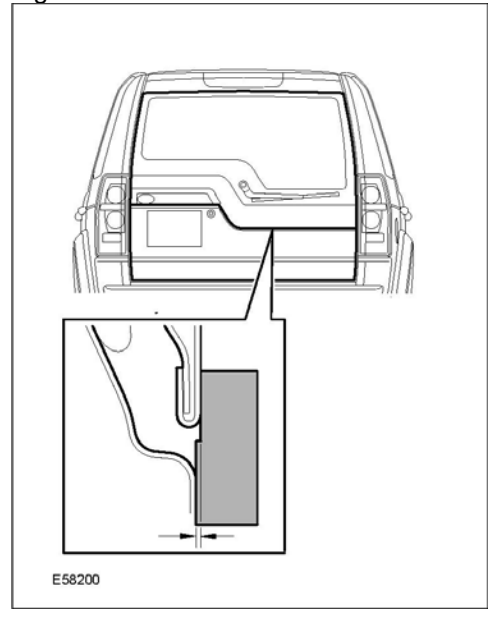
Figure 6

NOTE: The lower tailgate could be set too far forward on its strikers, requiring the upper tailgate to travel further inboard than necessary in order to latch.

4. Check for alignment of the lower tailgate with the tail lamps in the fore-aft direction on both sides.
5. Check for correct alignment between upper and lower tailgate as follows: (Figure 6)
 - Using a suitable implement, measure the gap between the upper and lower tailgate across the area of the latch.
 - Verify that the protrusion of the upper tailgate over the lower tailgate when closed is +1mm, with a tolerance or +1mm.
