TECHNICAL ALERT

No: TA501-001

Second Row Seat Release Strap Anchor Failure

Land Rover LR3 (LA)

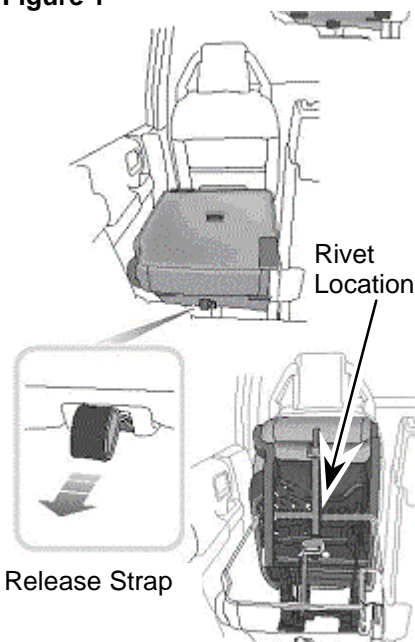
Figure 1

Field reports indicate that in use the second row seat bottom release strap (intended for third row passenger use to exit the vehicle and flip the seat bottom to the forward access position) can become disengaged from its retaining location. The retaining plastic rivet may have come loose. When this occurs the release latch will not disengage and the strap handle will pull out without resistance.

1. Release seat using side lever and flip to the forward position.
2. If present, remove Fir tree plastic rivet from the end of the strap and check that no part of the rivet is still lodged in the seat bottom.
3. Route the strap correctly to activate the latch. Use an undamaged seat for reference.
4. Align hole in strap with attachment hole in the bottom of the seat platform frame.
5. Insert specified rivet through the hole in the strap webbing
6. Install the rivet using the swivel head tool. (Figure 3 and Figure 4)
7. Test latch release function.
8. Place seat in the unfolded and latch position and test to ensure that the latch works properly.
