2001 Mercedes-Benz ML320

1998-2005 ACCESSORIES & BODY, CAB Interior Equipment - 163 Chassis

GENERAL INFORMATION

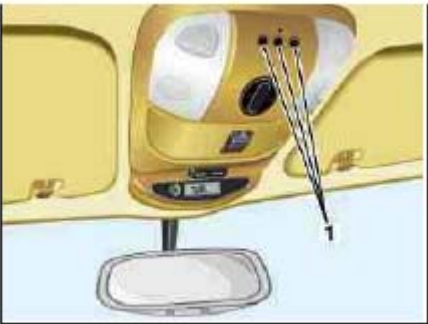
Fig. 3: Identifying Garage Door Opener Transmitter Buttons - Illustrated On Model 230

The transmitter keys (1) as well as the transmitter for opening the garage door are located in the mounting shaft between the interior lamps.

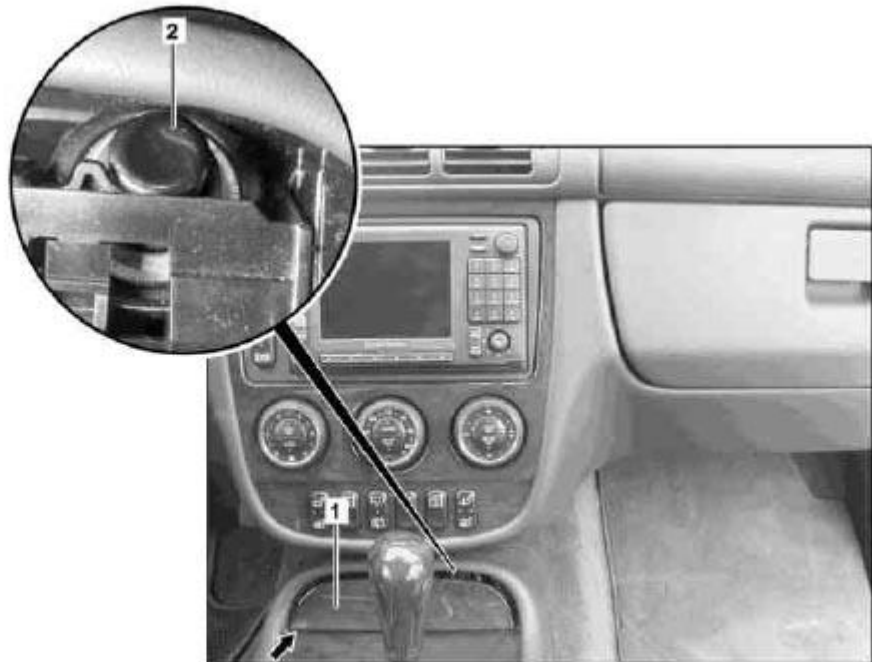
Fig. 5: Identifying Front Ashtray Cover & Cigarette Lighter

Damage code	Cause	Remedy	
	Cigarette lighter not fully seated, causing ashtray housing to jam when closed.

It is NOT necessary to replace the complete ashtray housing. 1 Using a long wedge, slide under edge of ashtray cover and pry up and out to remove. Support cover to prevent breaking tabs from abrupt release.

- 1 Front ashtray cover
2 Cigarette lighter
Arrow Lower left corner of front ashtray

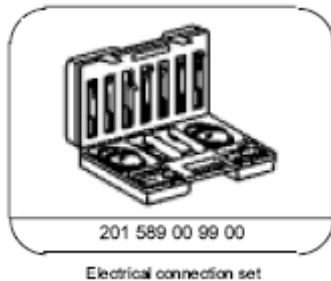
Fig. 7: Identifying Electrical Connection Set (201 589 00 99 00)

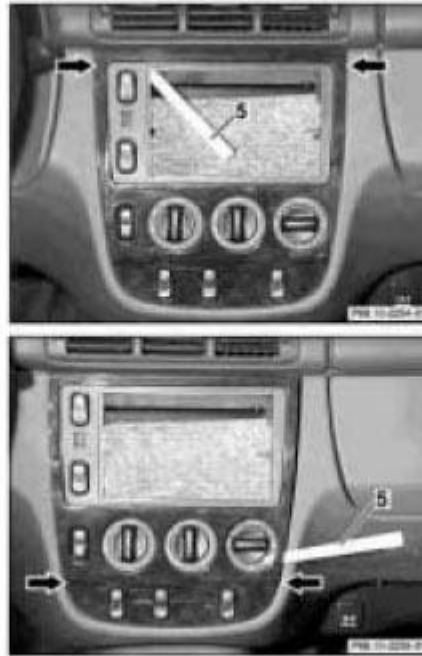
Fig. 11: Identifying Instrument Panel Center Section Components

- 1 Instrument panel
- 2 Instrument panel center section
- 3 Stowage compartment
- 4 In-car temperature sensor intake hose
- 5 Long wedge
- A2 Radio
- Arrows Retaining clips

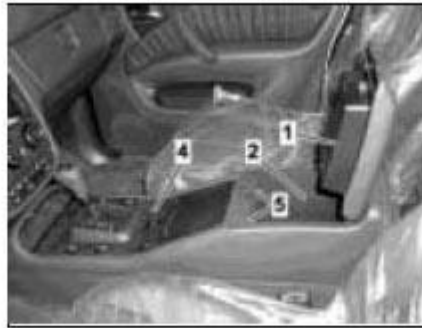
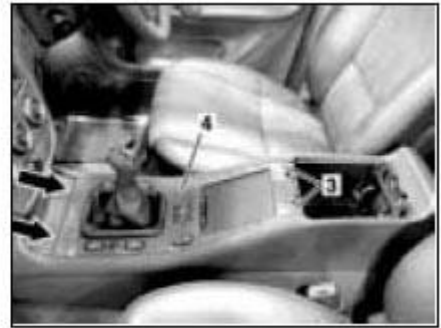
Fig. 49: Identifying Cover On Gearshift Lever

- 1 Armrest cover
- 2 Stowage box
- 3 Bolts
- 4 Cover on shift lever
- 5 Plastic screws

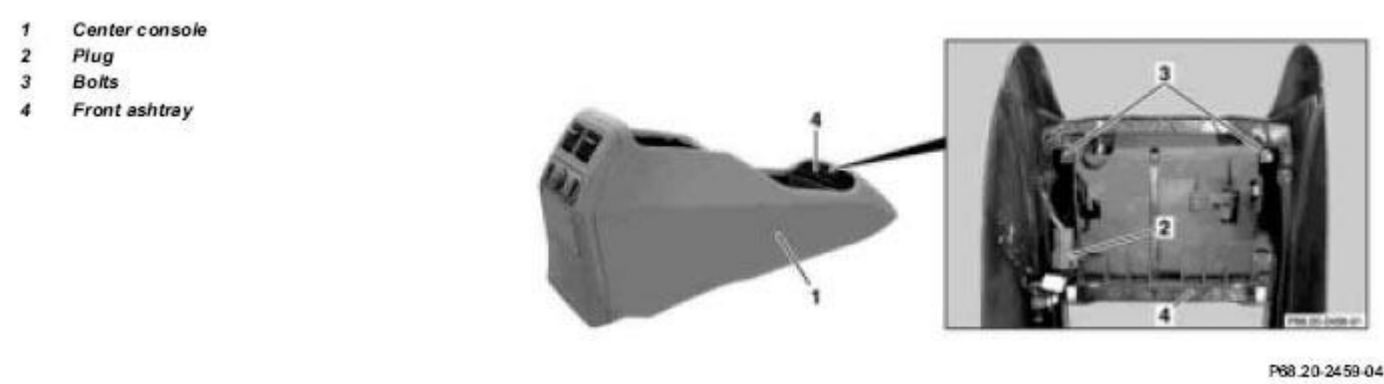
Fig. 55: Identifying Ashtray Housing In Front Center Console

Remove/install		
1	Remove center console (1)		<u>AR68.20-P-2000GH</u>
2	Lay center console down on suitable subsurface	Do not damage center console	
3	Disconnect plug (2)		
4	Remove bolts (3)		
5	Remove front ashtray (4)	Installation: Ensure that ashtray is seated correctly in center console.	
6	Install in the reverse order

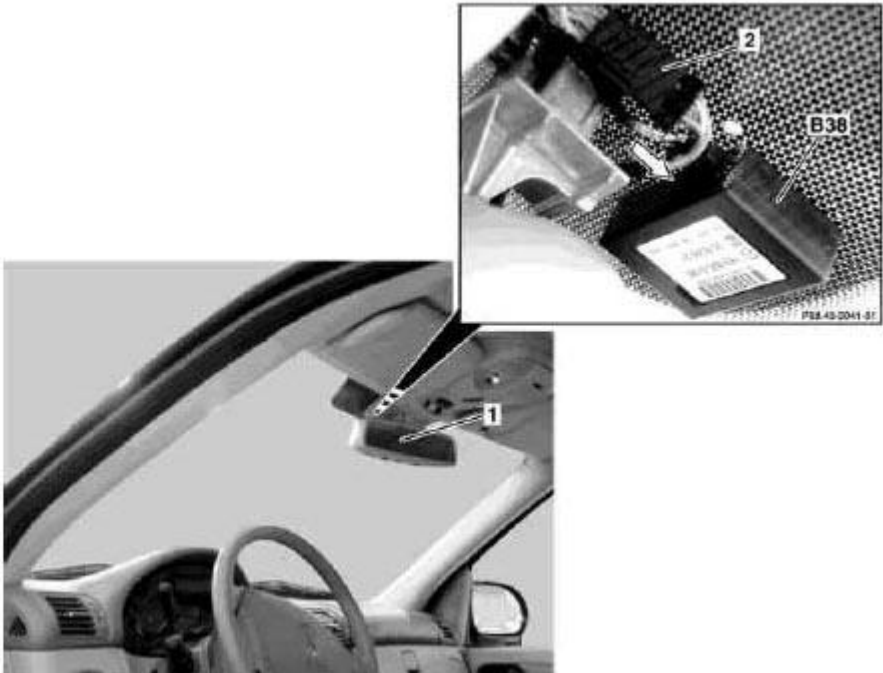
Fig. 74: Identifying Inside Rearview Mirror, Automatic Dimming Connector & Rain Sensor

- 1 Inside rearview mirror
- 2 Automatic dimming connector
- B38 Rain sensor

Remove/install	
1	Turn inside rearview mirror (1) 90 and press against mirror housing at side.	Danger of breaking windshield. Do not damage rain sensor (B38), if present.
2.1	Disconnect automatic dimming connector (2).	Only with automatically dimming inside rearview mirror, code 249a.
3	Install in the reverse order

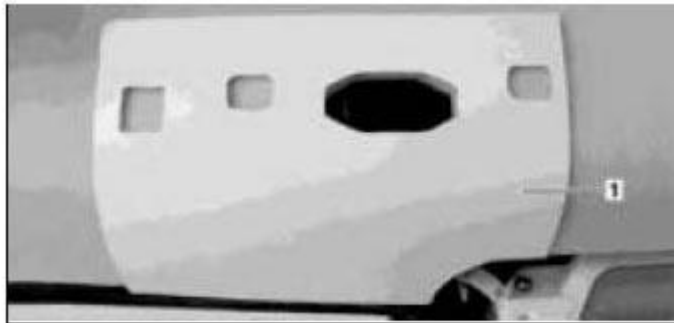
P68.30-2527-10

1. Remove accessory hook.
2. Position template (1) to roof paneling.
◀ Fasten template with adhesive tape.
3. Mark points which must be cut out for installing pivot handle and clamping strap.
4. Remove template (1).

Fig. 81: Identifying Pivot Handle Template
