VARIABLE VALVE TIMING ACTUATOR inspection

L3 (with variable valve timing mechanism)

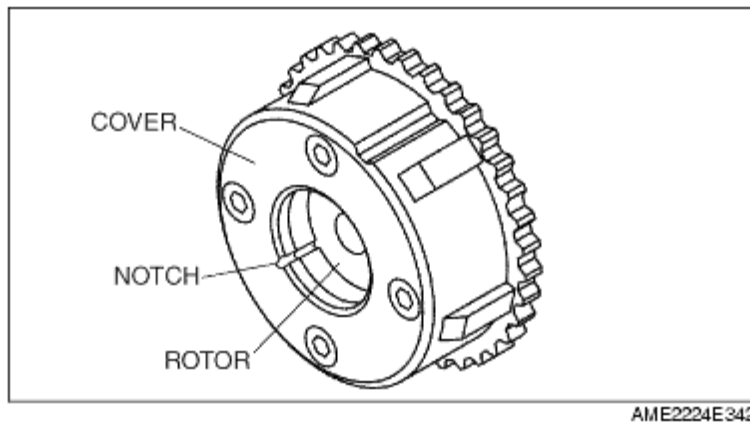
1. Confirm that notch of the rotor and bump of the cover at the variable valve timing actuator are aligned and fitted.

- If the notch and the bump are not aligned, rotate the rotor toward the bulb timing retard position by hand until they are in place.
- If the rotor and cover are not secured even though their notch and groove are aligned, replace the variable valve timing actuator.
