# VARIABLE VALVE TIMING ACTUATOR INSPECTION

## L3 (with variable valve timing mechanism)

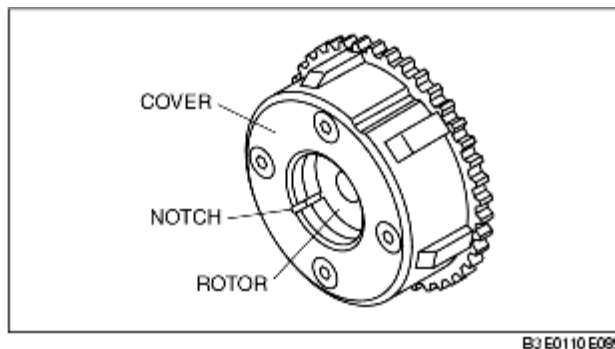
1. Confirm that the groove of the rotor and notch of the cover at the variable valve timing actuator are aligned and fixed.

- If the notch and the bump are not aligned, rotate the rotor toward the valve timing retard position by hand until they are in place.
- If the rotor and cover are not fixed even though their notch and groove are aligned, replace the variable valve timing actuator.
