FILAMENT INSPECTION

B3E091263000W01

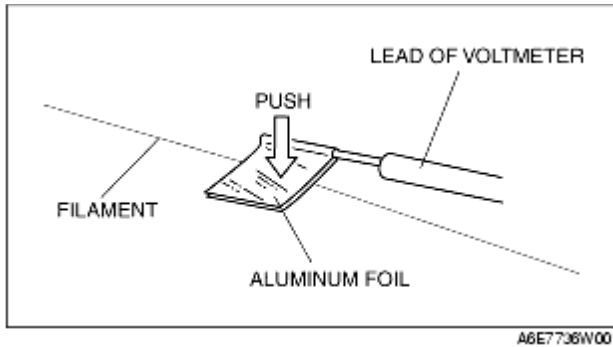
1. Turn the ignition switch to the ON position.
2. Turn the rear window defroster switch on.

- Directly touching the rear window defroster filament with the lead of the tester could damage it. Wrap aluminum foil around the end of the lead and inspect the filament by touching it with the foil.

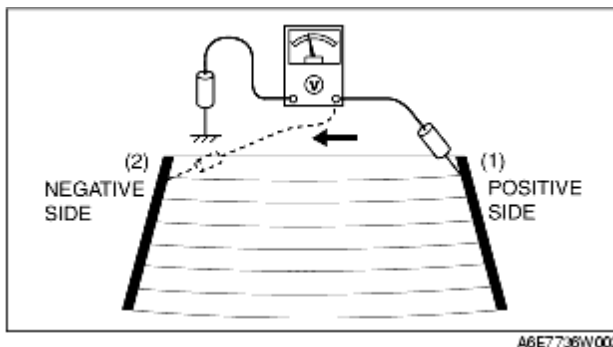
3. Connect the positive lead of the tester to the positive side of each filament and the negative lead to ground.
4. Gradually slide the positive lead from the positive side to the negative side and verify that the voltage decreases accordingly.

- If the voltage changes rapidly, the filament has a malfunction. Repair the filament.

Measured part	Voltage (Reference)
(1) to (2)	Approx. 12 V to 0 V
