SEAT WARMER SWITCH INSPECTION

B3E091388110W02

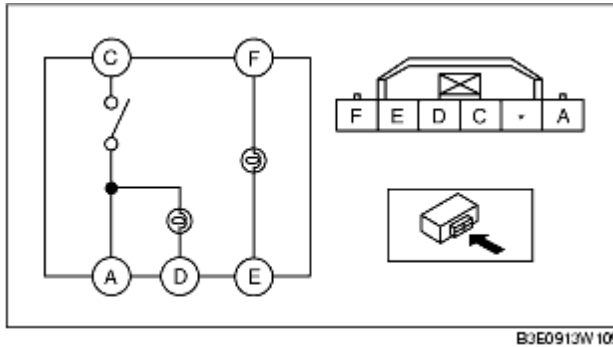
B3E0913W 110

1. Verify that the continuity between the seat warmer switch terminals is as indicated in the table.

- If not as indicated in the table, replace the seat warmer switch.
