SEAT WARMER UNIT INSPECTION

B3E091388110W03

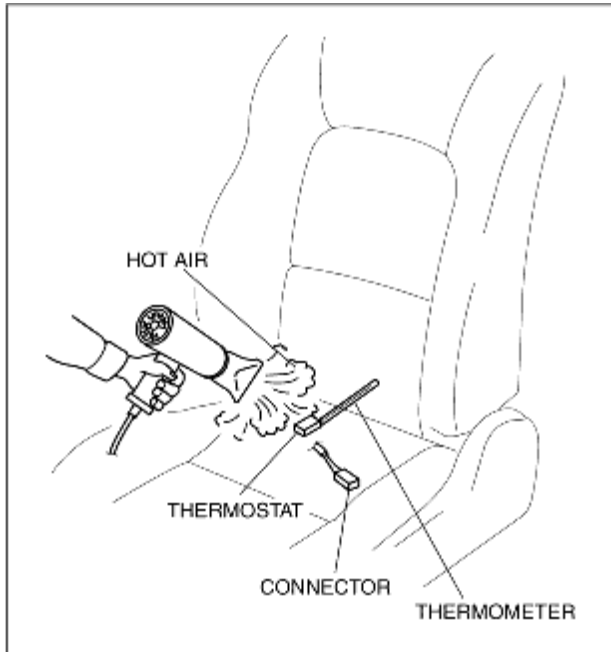
B3E0913W111

1. Remove the front seat. (See [FRONT SEAT REMOVAL/INSTALLATION.](#))
2. Remove the seat cushion trim. (See [FRONT SEAT DISASSEMBLY/ASSEMBLY.](#))
3. While inspecting for continuity between the terminals A and B of the connector, use a dryer to warm the thermostat of the seat warmer unit on seat cushion.

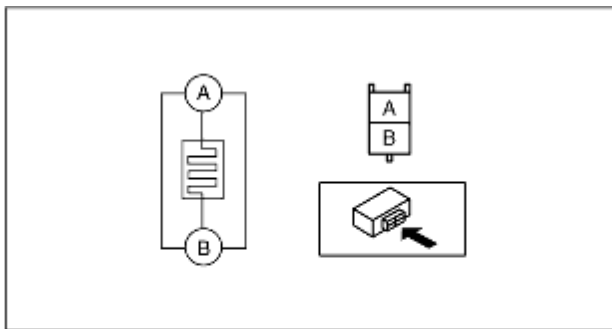
B3E0913W112

4. Verify that the continuity between the seat warmer terminals is as indicated in the table.

Thermostat temperature	Terminal	
	A	B
More than approx. 37 °C {99 °F}		
Less than approx. 27 °C {81 °F}	○ — ○	○ — ○

- If not as indicated in the table, replace the seat warmer switch.
