REAR ANTENNA FEEDER INSPECTION

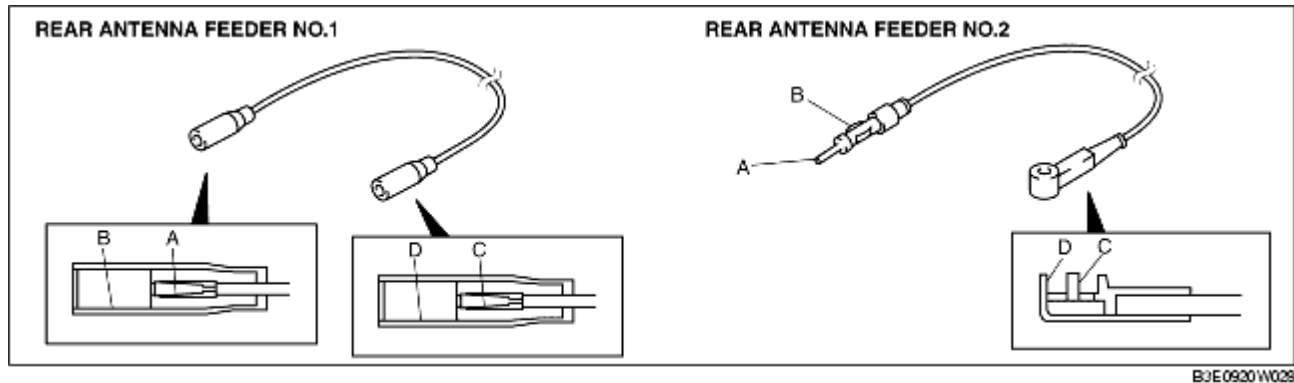
1. Verify that there is no continuity between the front antenna feeder terminal A and B.
2. Verify that the continuity is as indicated in the table.

Step	Terminal			
	A	B	C	D
1	○	—	○	
2		○	—	○

○—○ : Continuity

- If not as indicated in the table, replace the rear antenna feeder No.1 or No.2.
