## INSPECTION

### 1. VEHICLES NOT INVOLVED IN COLLISION

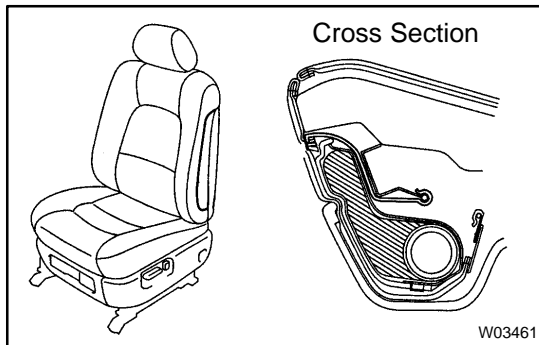
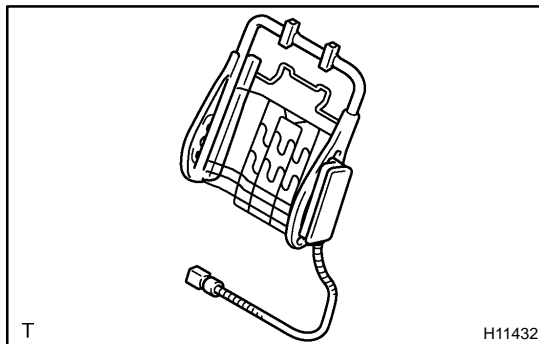
- (a) Do a diagnostic system check. (See page [DI-459](#))
- (b) Do a visual check which includes the following item with the side airbag assembly installed in the vehicle.

Check that there are no cuts or the frayed on seams and out side of seatback cover.
