CAMSHAFT POSITION (CMP) SENSOR REMOVAL/INSTALLATION [ZJ, Z6]

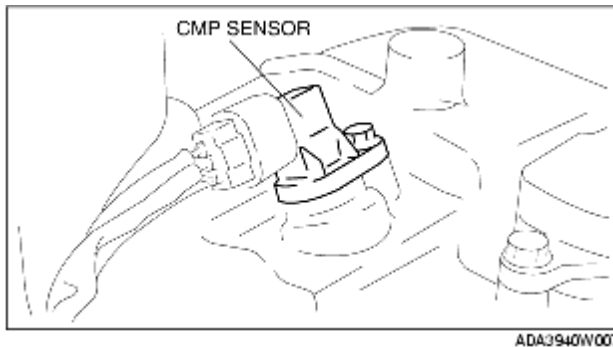
1. Remove the battery cover. (See [BATTERY REMOVAL/INSTALLATION \[ZJ, Z6\]](#).)
2. Disconnect the negative battery cable.
3. Remove the CMP sensor.

4. Verify that the O-ring is not damaged.
 - If there is a damage, replace the CMP sensor.
5. Apply a small amount of clean oil to the O-ring and the head cover.
6. Install in the reverse order of removal.

CMP sensor tightening torque
7.8-10.8 N·m {80-110 kgf·cm, 70-94 in·lbf}
