CRANKSHAFT POSITION (CKP) SENSOR REMOVAL/INSTALLATION [ZJ, Z6]

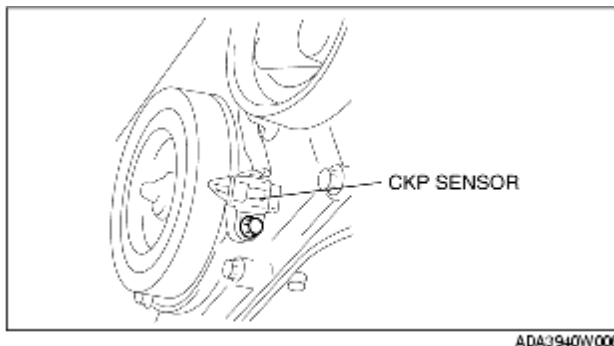
ADA0940W006

1. Remove the battery cover. (See [BATTERY REMOVAL/INSTALLATION \[ZJ, Z6\]](#).)
2. Disconnect the negative battery cable.
3. Perform the following procedure for easier access.
 - (1) Remove the under cover.
4. Remove the CKP sensor.

CKP sensor tightening torque
7.8-10.8 N·m {80-110 kgf·cm, 70-94 in·lbf}
