## B-Pillar Outer Panel

### Removal

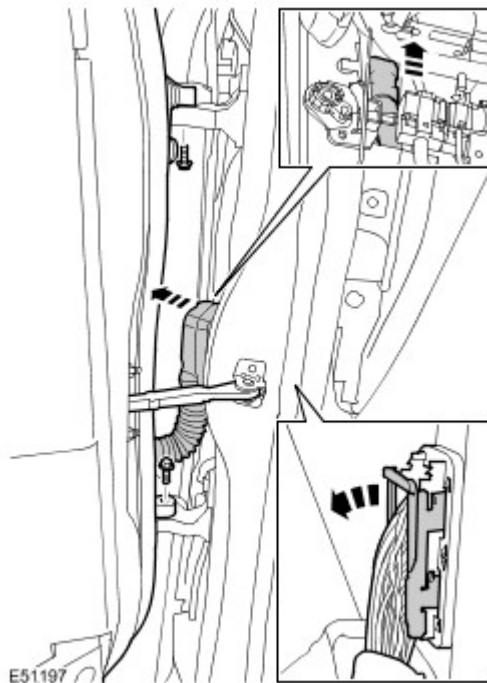
- 1 . Disconnect both battery cables. For additional information, refer to [Specifications](#) (Section 414-00 )
- 2 . Remove the rear door assembly.
  - Disconnect the electrical connector
  - Release the wiring harness grommet
  - Release the wiring harness retaining clip
  - Remove the 2 bolts

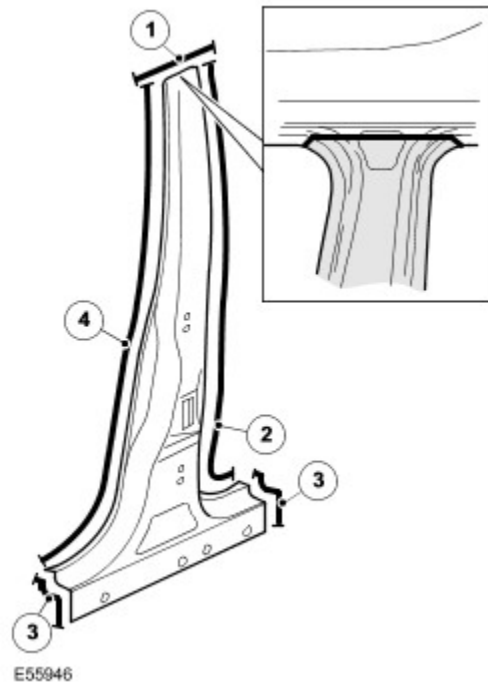
Item	Description
1	Cut line and butt weld.
2,4	81 spot welds.
3	Butt welds.

- 9 . Release the wiring harness from the rocker panel.
- 10 . Remove the front safety belt retractor. For additional information, refer to [Front Safety Belt Retractor \(76.73.13\)](#) (Section 501-20A )
- 11 . Remove the rocker panel outer trim.
- 12 . Release the carpet.
- 13 .

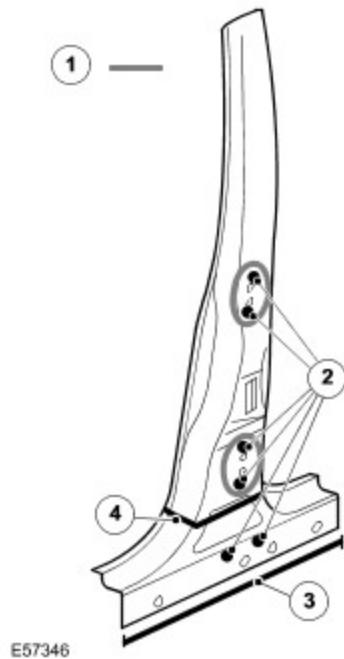
Item	Description
1	Adhesive.
2	6 plug welds.
3	19 plug welds.
4	Acoustic seal.

- Welding. For additional information, refer to [Body Repairs](#) (Section 501-25A Body Repairs - General Information)
- Corrosion protection. For additional information, refer to [Corrosion Protection](#) (Section 501-25B Body Repairs - Corrosion Protection)
- Tolerance checks. For additional information, refer to [Body and Frame](#) (Section 501-26 Body Repairs - Vehicle Specific Information and Tolerance Checks)
