DRIVE BELT INSPECTION [ZJ, Z6]

B3E011015800W02

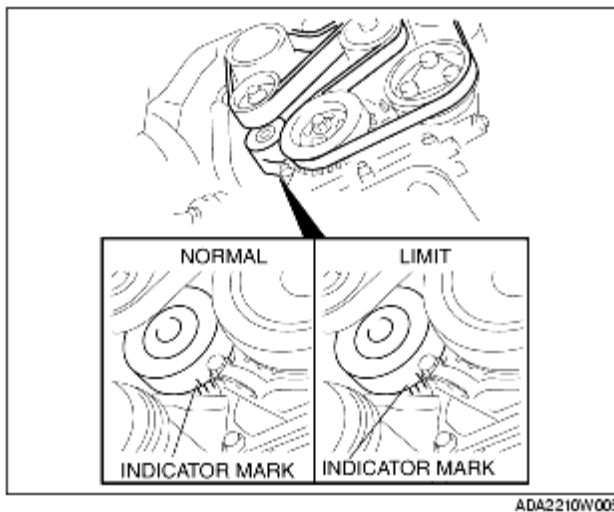
1. Remove the under cover and splash shield (RH).
2. Verify that the drive belt auto tensioner indicator mark does not exceed the limit.

- If it exceeds the limit, replace the drive belt. (See [DRIVE BELT REPLACEMENT \[ZJ, Z6\]](#).)
