## FRONT LOWER ARM INSPECTION

B3E021334300W02

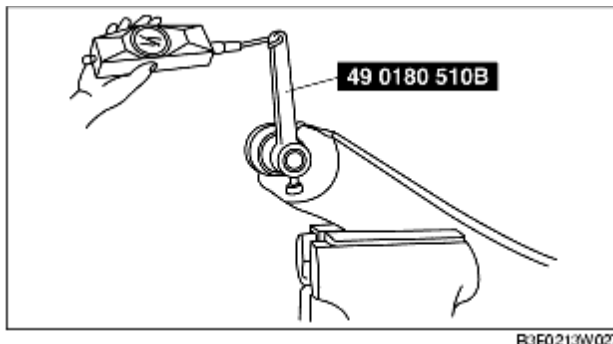
1. Remove the lower arm from the vehicle.
2. Inspect the arm for bending or damage, and the ball joint for excessive looseness.
  - If there is any malfunction, replace the lower arm.
3. Rotate the ball joint stud **5 times**. Install the **SST** to the ball joint stud, measure the rotational torque using a pull scale.

- If not within the specification, replace the lower arm.

**Rotational torque****1.0-4.9 N·m {11-49 kgf·cm, 9-43 in·lbf}****Pull scale reading [10-49 N {1.1-4.9 kgf, 3-10 lbf}]**
