FRONT BRAKE (DISC) INSPECTION

Brake Judder Repair Hints

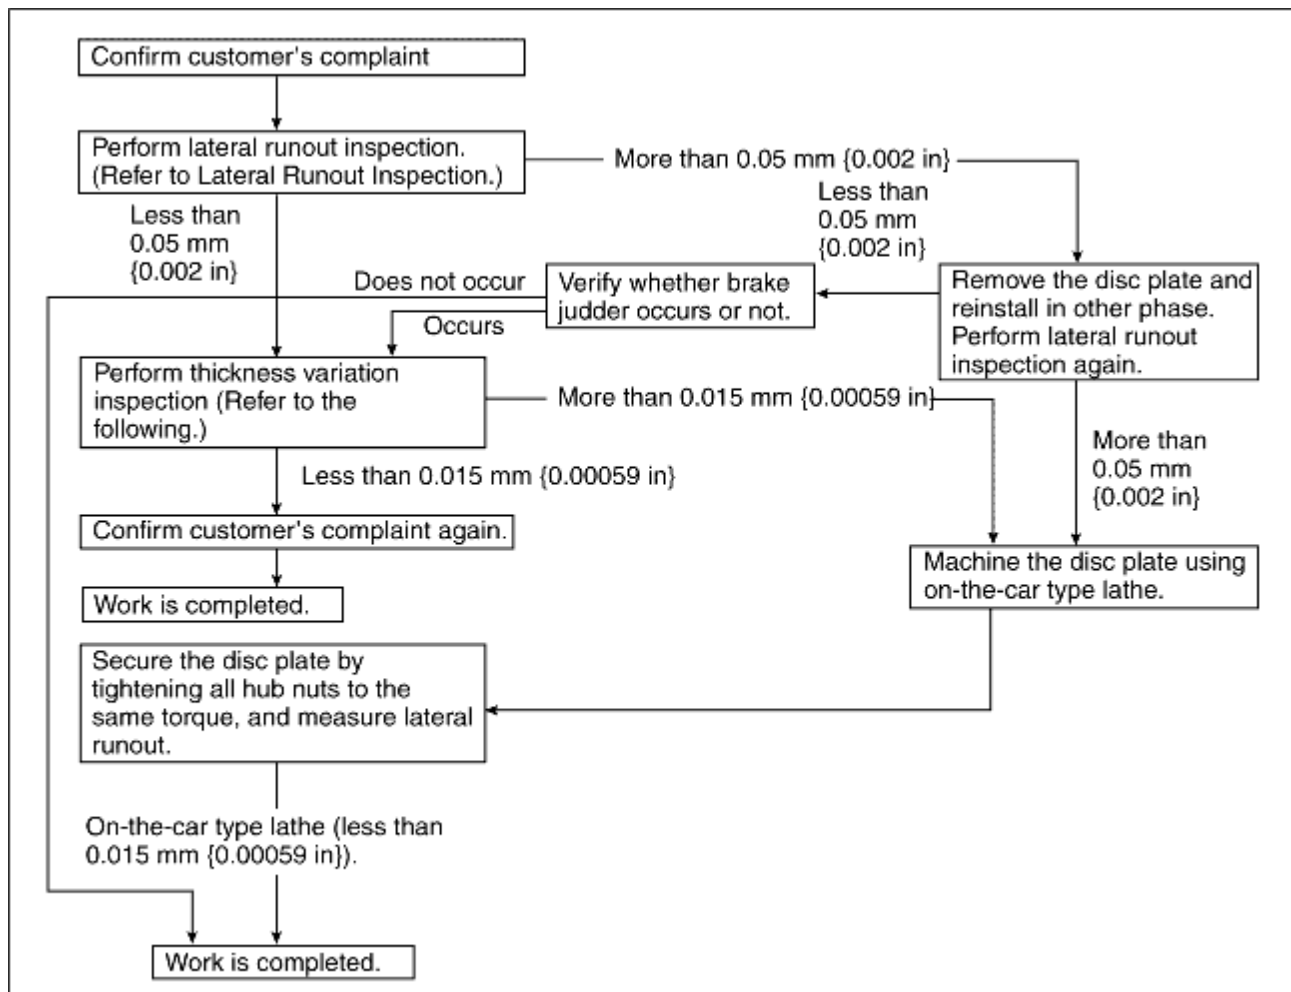
B3E0411W021

Inspection and repair procedure

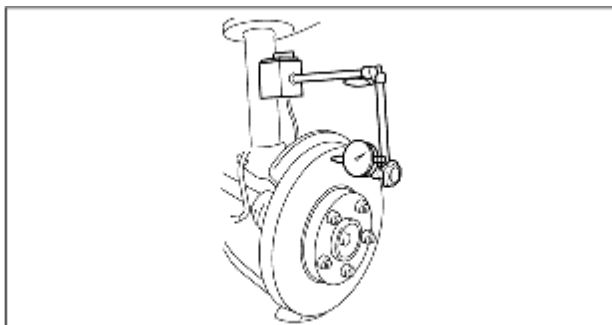
B3E0411W013

Lateral runout inspection

1. To secure the disc plate and the hub, insert the washer (thickness **10 mm {0.39 in}**, inner diameter **more than 12 mm {0.47 in}**) between each hub bolt and the hub nut, then tighten all the hub nuts.

2. After tightening all the hub nuts to the same torque, put the dial gauge on the friction surface of the disc plate **10 mm {0.39 in}** from the disc plate edge.

3. Rotate the disc plate one time and measure the runout.

Runout limit
0.05 mm {0.002 in}

1. If the runout is **more than 0.05 mm {0.002 in}** at the position **10 mm {0.39 in}** from the disc plate edge, uneven wear occurs on the disc plate because the pad contacts the plate unevenly.
2. If the runout is **less than 0.05 mm {0.002 in}**, uneven wear does not occur.

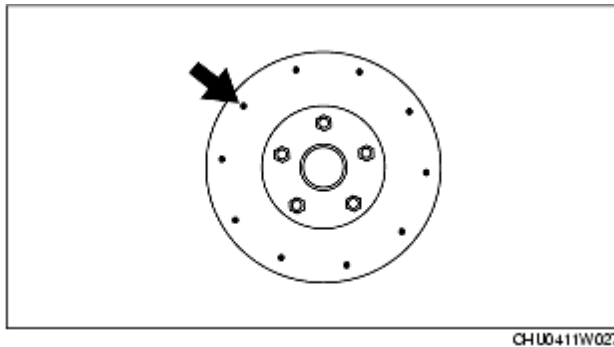
Thickness variation inspection

1. Clean the disc plate-to-pad friction surface using a brake cleaner.
2. Measure the points indicated in the illustration using a caliper (micrometer).

3. Subtract the minimum value from the maximum, and if the result is not within the specification, machine the disc plate using a lathe.

Thickness variation limit
0.015 mm {0.00059 in}

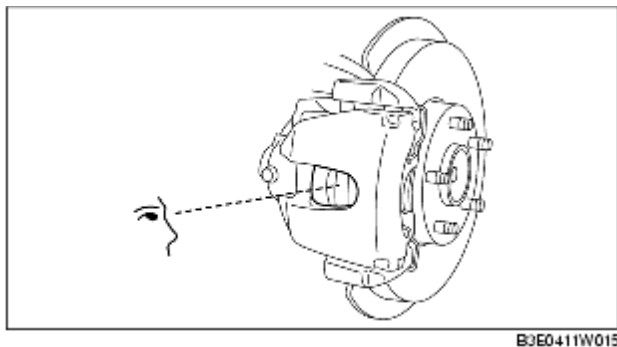
Disc Pad Thickness Inspection

1. Jack up the front of the vehicle and support it with safety stands.
2. Remove the wheels and tires.
3. Verify the remaining thickness of the pads.

Minimum thickness
2.0 mm {0.079 in} min.

4. Replace the pads as a set (right and left wheels) if either one is at or less than the minimum thickness.
