POWER MOS FET INSPECTION

B3E074000116W02

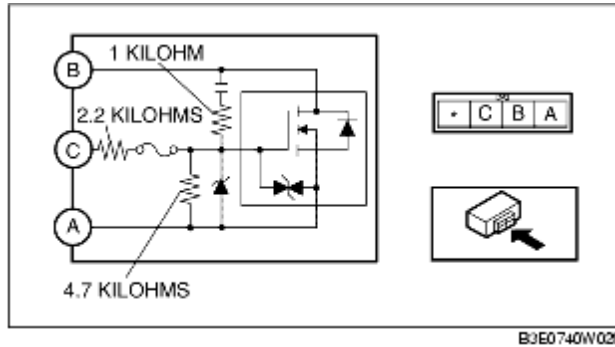
1. Verify that the continuity between the power MOS FET terminals is as indicated in the table.

Tester lead		Resistance (kilohm)
+	-	
A	B	∞
A	C	6.9
B	A	Continuity detected
B	C	Continuity detected
C	A	6.9
C	B	∞

- If there is any malfunction, replace the power MOS FET.
- If the blower motor operation is not normal even though no malfunction can be verified, inspect the climate control unit. (See [CLIMATE CONTROL UNIT INSPECTION \[FULL-AUTO AIR CONDITIONER\]](#).)
