FAN SWITCH INSPECTION

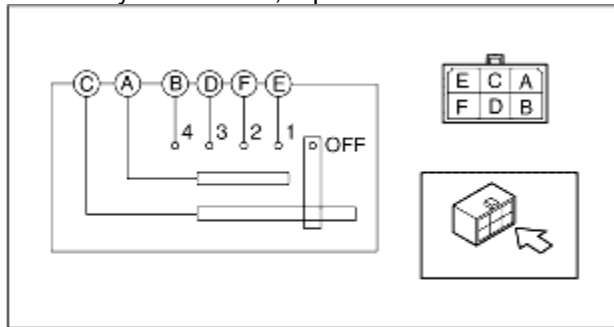
B3E0740W060

1. Remove the climate control unit.
2. Verify that the continuity between the fan switch terminals is as indicated in the table.
 - If there is any malfunction, replace the fan switch.

Switch position	Terminal					
	A	B	C	D	E	F
0						
1	○	—	○	—	○	
2	○		○			○
3	○	—	○	○		
4	○	○	○
