CLOCK SPRING INSPECTION

B3E081066123W03

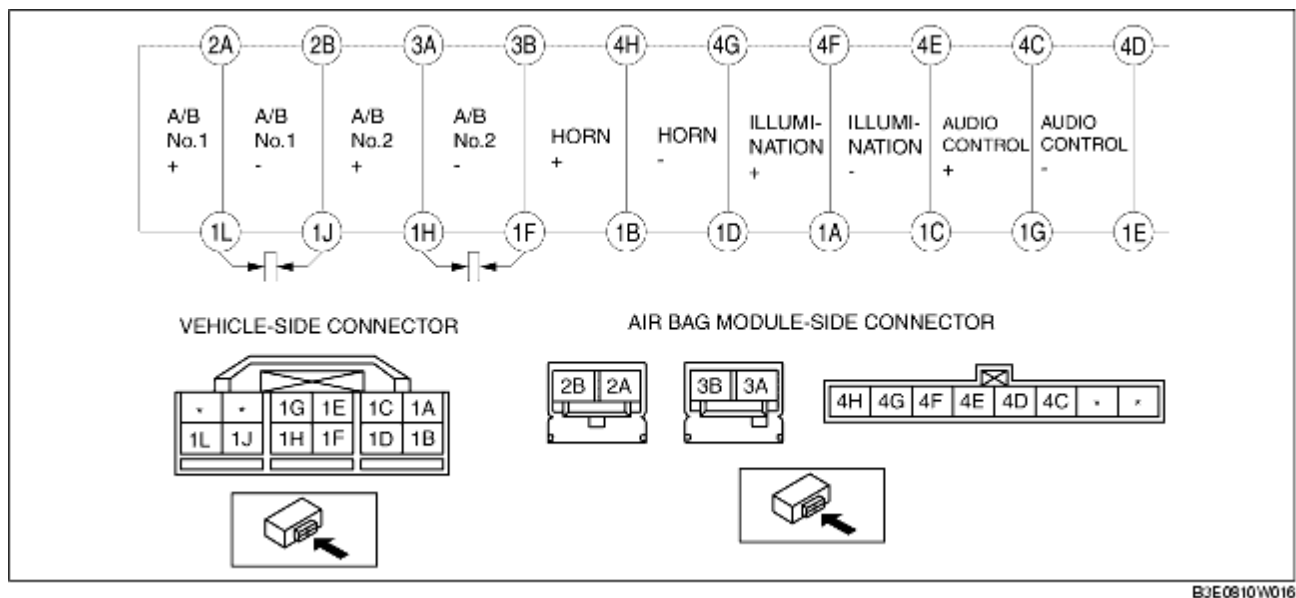
B3E0810W015

2. Verify that the continuity is as indicated in the table.

- When the vehicle-side connector for the clock spring is disconnected, terminals 1F, 1H, 1J and 1L are shorted to prevent unexpected operation (deployment) of the air bag module.

○—○ : Continuity

Test condition	Terminal															
	1A	1B	1C	1D	1E	1F	1G	1H	1J	1L	2A	2B	3A	3B	4C	4D
Under any condition									○	○	○	○				
						○		○					○	○		
		○														○
	○			○												
			○													○
							○								○

- If not as indicated in the table, replace the clock spring.
