## SUNROOF SWITCH INSPECTION

B3E091566560W02

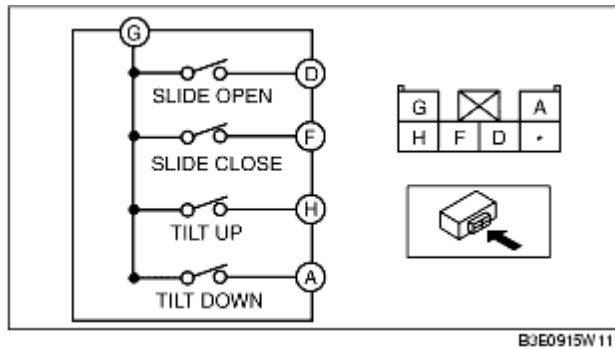
B3E0915W 112

1. Verify that the continuity between the sunroof switch terminals is as indicated in the table.

Switch position	Terminal				
	A	D	F	H	G
Slide open		○		○	○
Slide close			○	○	○
Tilt up				○	○
Tilt down	○				○
OFF

○ — ○ : Continuity

- If not as indicated in the table, replace the sunroof switch.
