BACK-UP LIGHT SWITCH INSPECTION

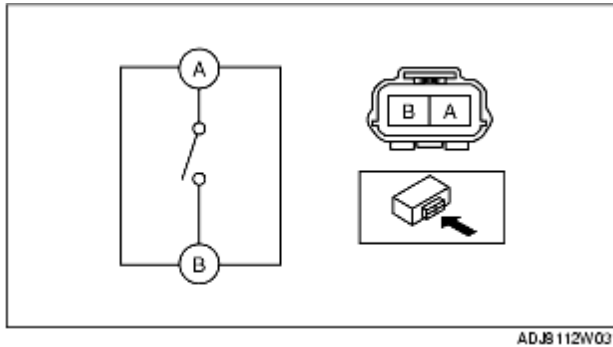
B3E0919W164

1. Verify that the continuity between the back-up light switch terminals is as indicated in the table.

Shift lever position	Terminal	
	A	B
Reverse	○ — ○ : Continuity	
Except above

- If not as indicated in the table, replace the back-up light switch.
