LIGHT SWITCH INSPECTION

B3E091866121W02

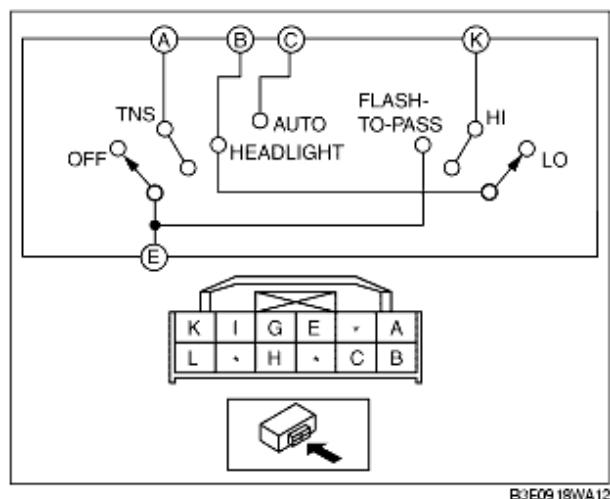
Headlight Switch

1. Verify that the continuity between the light switch terminals is as indicated in the table.

Switch position			Terminal				
Light	Dimmer	Flash-to-pass	A	B	C	E	K
OFF	—	OFF					
		ON		○—○		○—○	○—○
TNS	—	OFF	○—○	○—○		○—○	
		ON	○—○	○—○		○—○	○—○
Head light	LO	OFF	○—○	○—○		○—○	
		ON	○—○	○—○		○—○	○—○
	HI	—	○—○	○—○		○—○	○—○
Auto	LO	OFF	○—○	○—○	○—○	○—○	
		ON	○—○	○—○	○—○	○—○	○—○
	HI	—	○—○	○—○	○—○	○—○	○—○

- If not as indicated in the table, replace the light switch.
