# HEADLIGHT LEVELING SWITCH INSPECTION

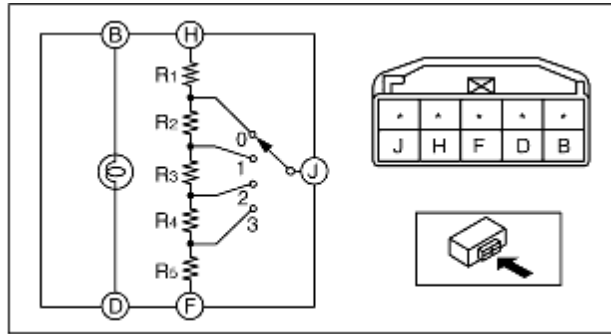
B3E0918WA11

1. Verify that continuity between the headlight leveling switch terminals is as indicated in the table.

Switch position	Terminal				
	B	D	H	J	F
0	○—○	○—○	○—R <sub>1</sub> —○	○—R <sub>2</sub> —R <sub>3</sub> —R <sub>4</sub> —R <sub>5</sub> —○	
1	○—○	○—○	○—R <sub>1</sub> —R <sub>2</sub> —○	○—R <sub>3</sub> —R <sub>4</sub> —R <sub>5</sub> —○	
2	○—○	○—○	○—R <sub>1</sub> —R <sub>2</sub> —R <sub>3</sub> —○	○—R <sub>4</sub> —R <sub>5</sub> —○	
3	○—○	○—○	○—R <sub>1</sub> —R <sub>2</sub> —R <sub>3</sub> —R <sub>4</sub> —○	○—R <sub>5</sub> —○

R<sub>1</sub> : 715 ohms    R<sub>2</sub> : 715 ohms    R<sub>3</sub> : 261 ohms  
R<sub>4</sub> : 604 ohms    R<sub>5</sub> : 715 ohms

- If not as indicated in the table, replace the headlight leveling switch.
