FRONT TWEETER INSPECTION

B3E092066961W06

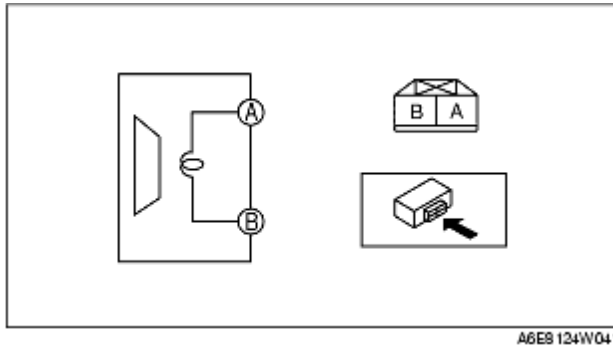
1. Verify the resistance between front tweeter terminals.

Resistance
3.2 ohms

- If the resistance is not within the specification, replace the front tweeter.

2. Connect a **1.5 V** battery to the front tweeter and verify that noise is sound from the front tweeter.

- If no sound is output, replace the front tweeter.
